**AN5116-06B**

**Optical Line Terminal Equipment**

**Troubleshooting Guide**

**FiberHome Telecommunication Technologies Co., Ltd.**

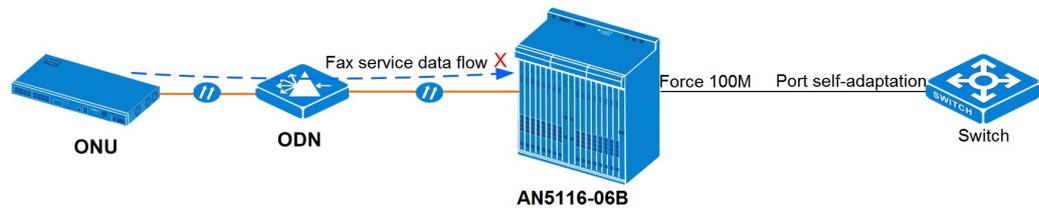
Figure 7-10 Incorrect uplink port mode configuration causing connection failure in fax service

1. Check the fax service configuration of the ONU, and find that the fax mode is set to transparent.
2. Perform packet capture on the uplink port of the AN5116-06B. By analyzing the data, we find that when the media gateway server interacts with the voice gateway, a 6% packet loss rate occurs. So we isolate the fault between the AN5116-06B and the upper layer network.
3. Check the working mode of the previous switch port and find it to be **Auto-negotiate**. Check the uplink port working mode of the AN5116-06B and find it to be **100Mbps and Full-Duplex**. The working modes of the two sets of equipment do not match.
4. Modify the working mode of the AN5116-06B uplink port to **Auto-negotiate**; the fax service resumes and the fault is eliminated.
